Water Friendly Farming Phase 2

Funded by RFCC Anglian North and EA

19th July 2024

Prof. Jeremy Biggs (Freshwater Habitats Trust)

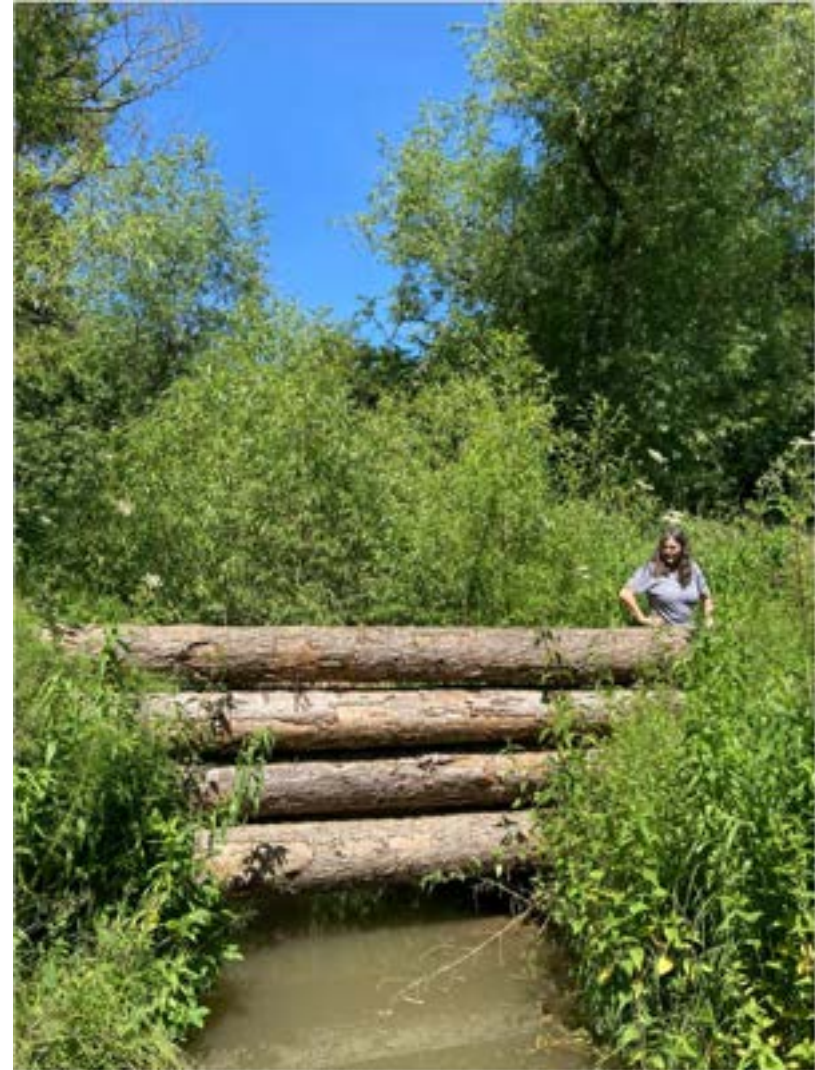
New style leaky dam on the Eye Brook

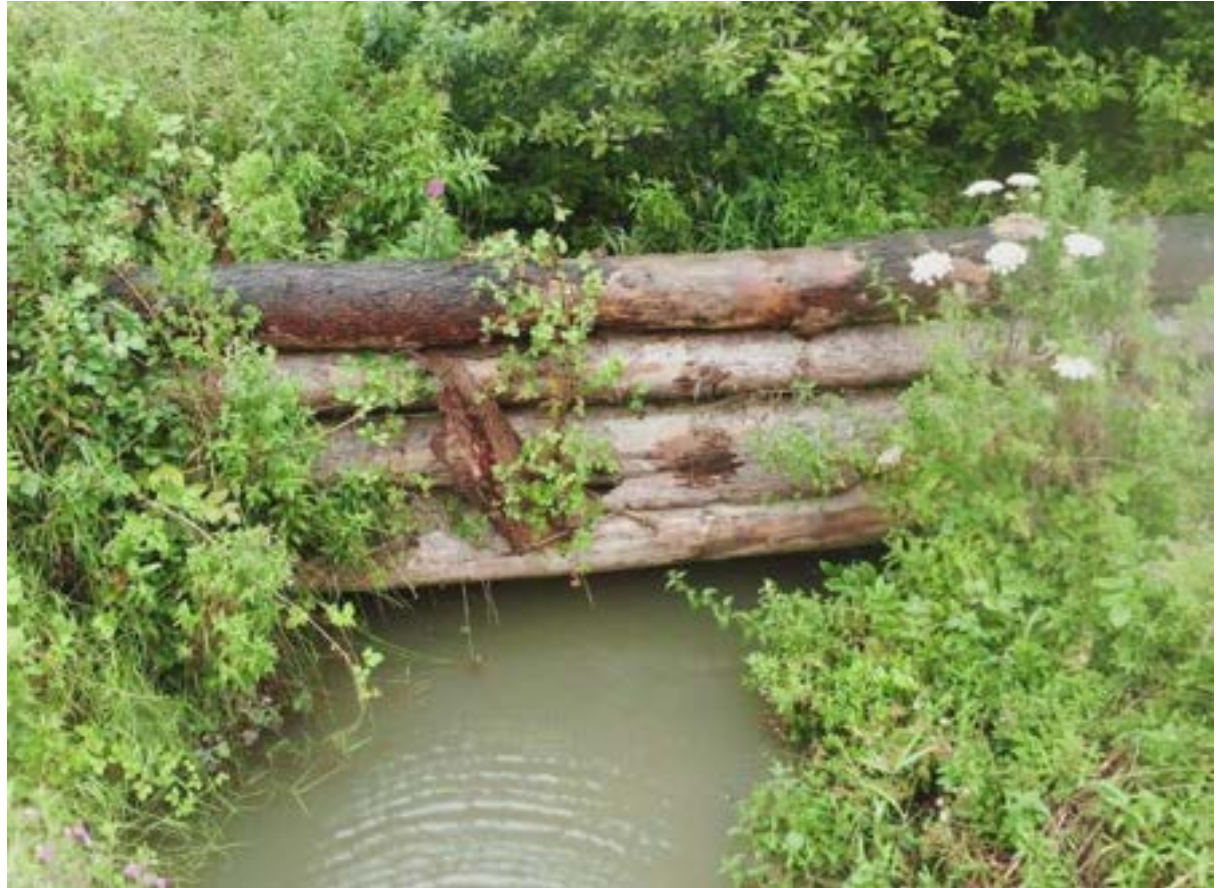
Leaky dam on the Eye Brook

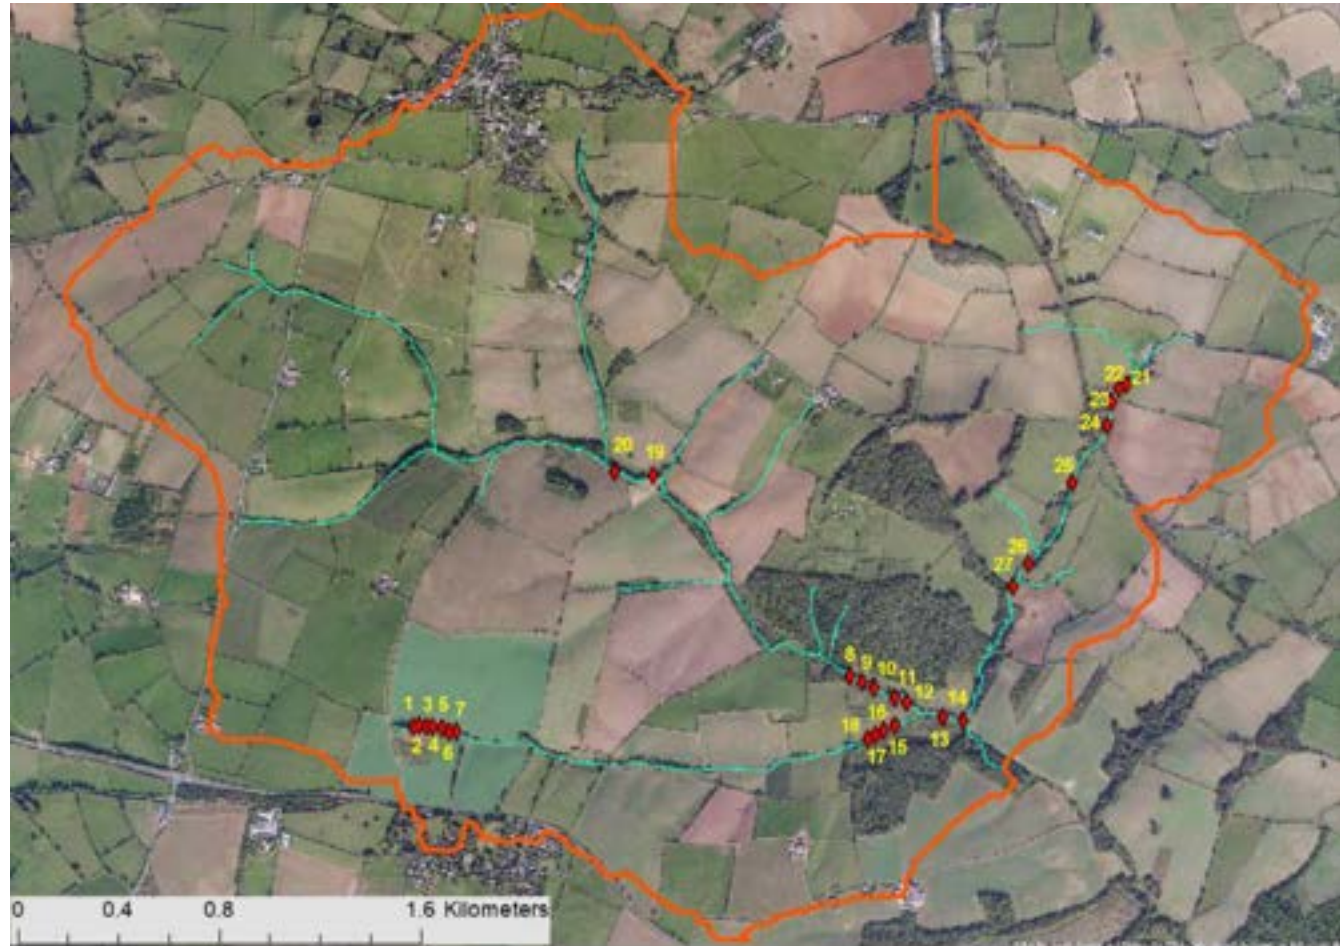
Location of leaky dams on the Eye Brook

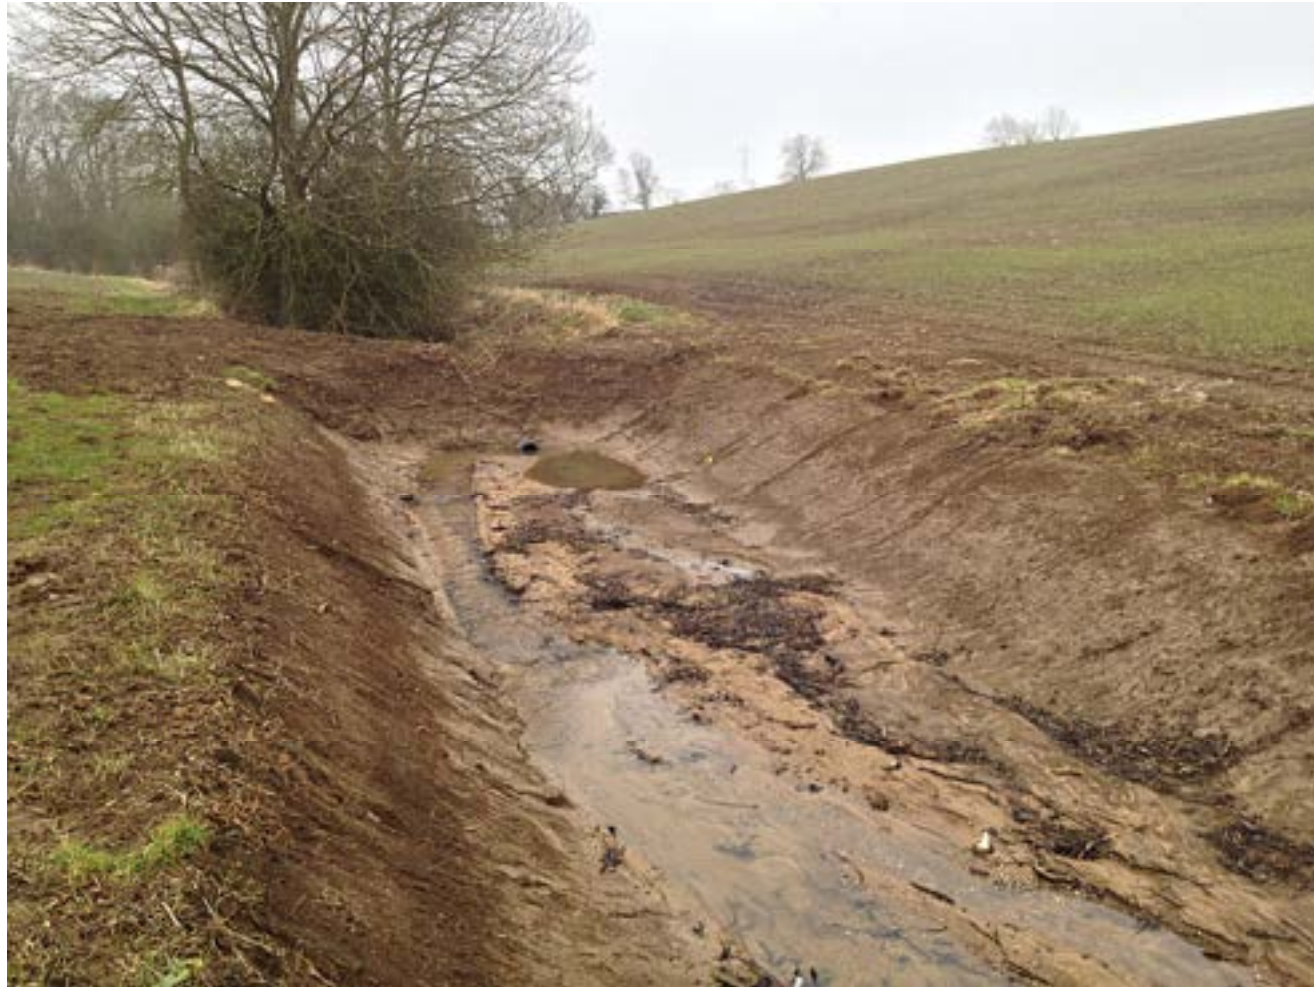
Bunded ditch on Eye Brook tributary

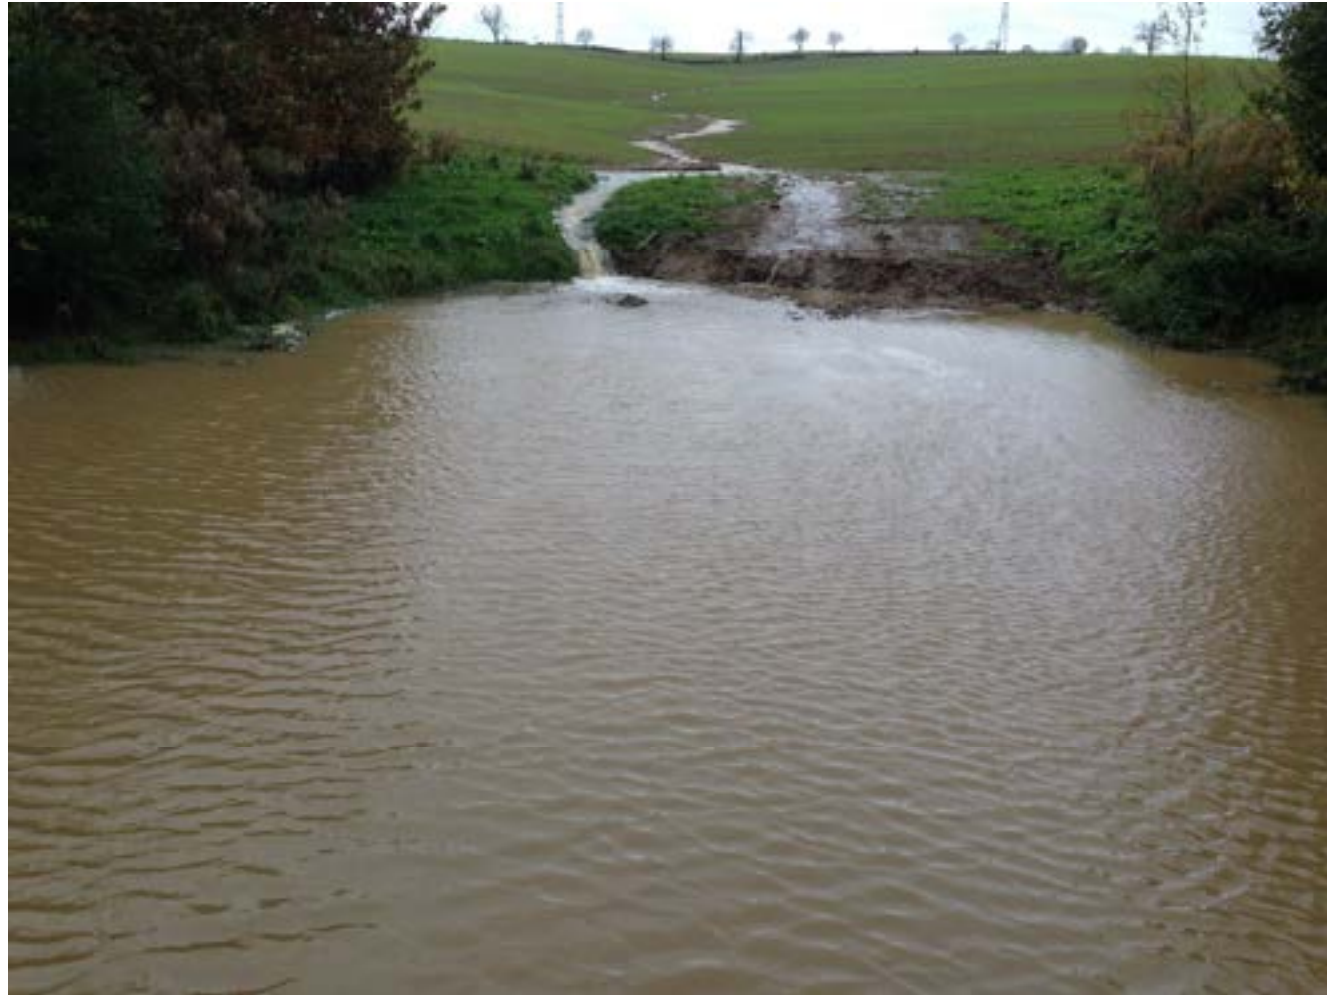
Field drain interception pond

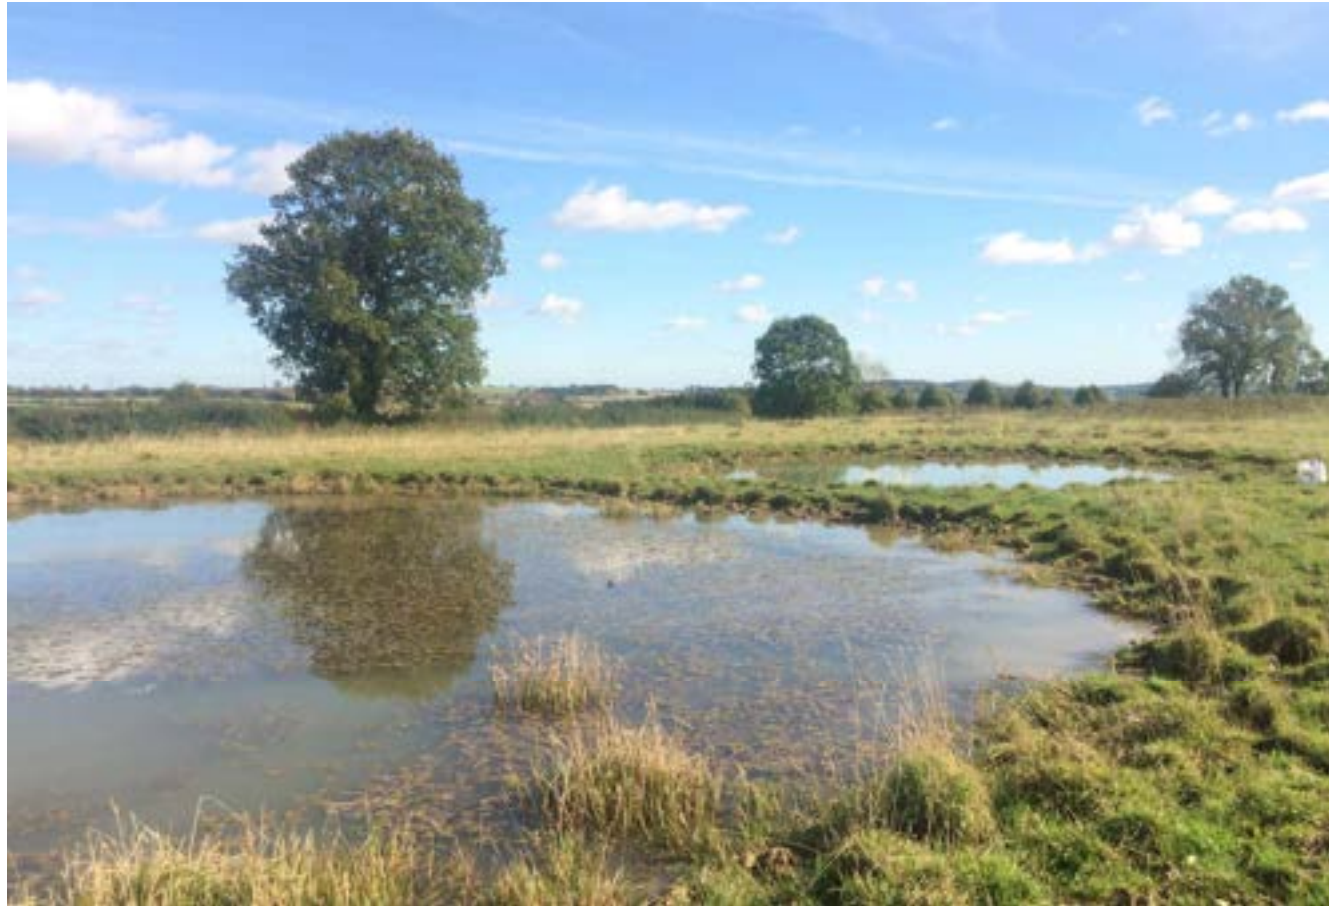
Clean water pond, Stonton Brook catchment

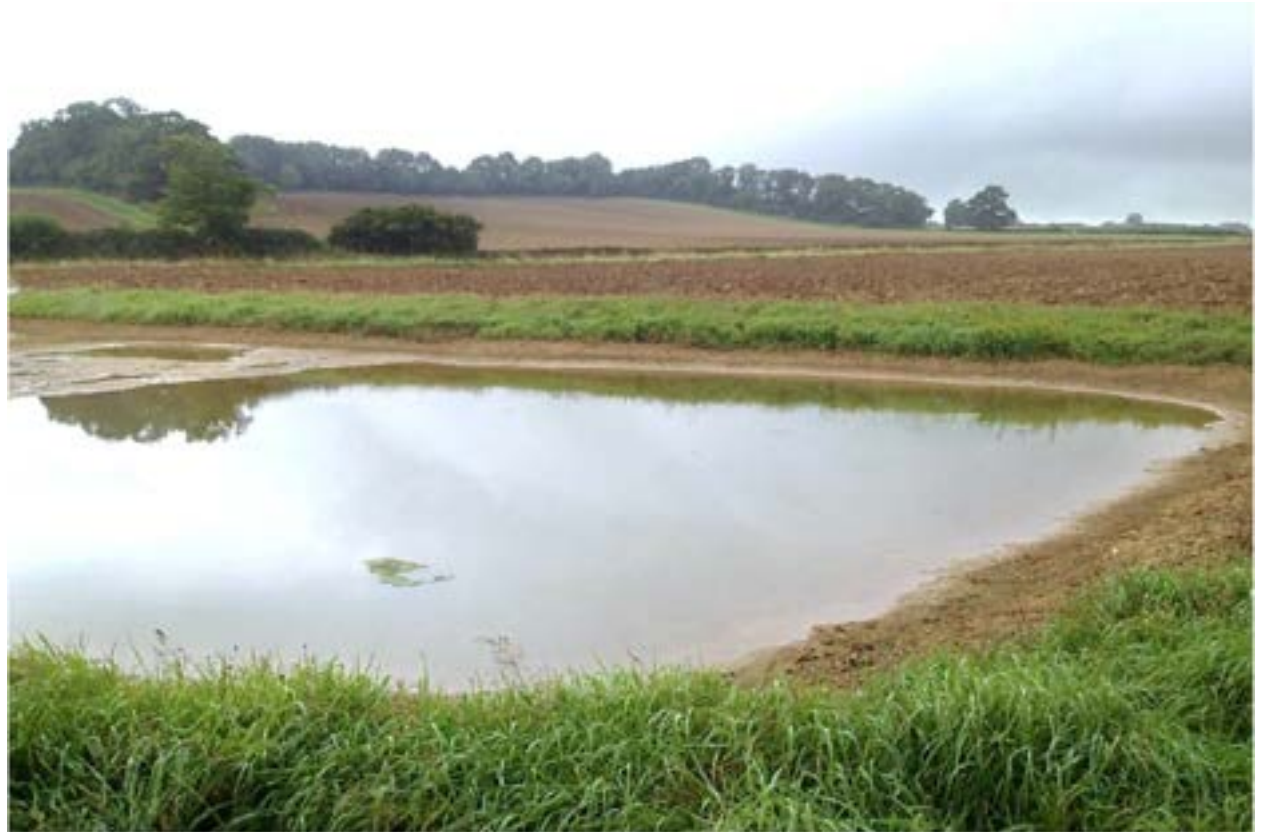
Flood storage basin on the Eye Brook

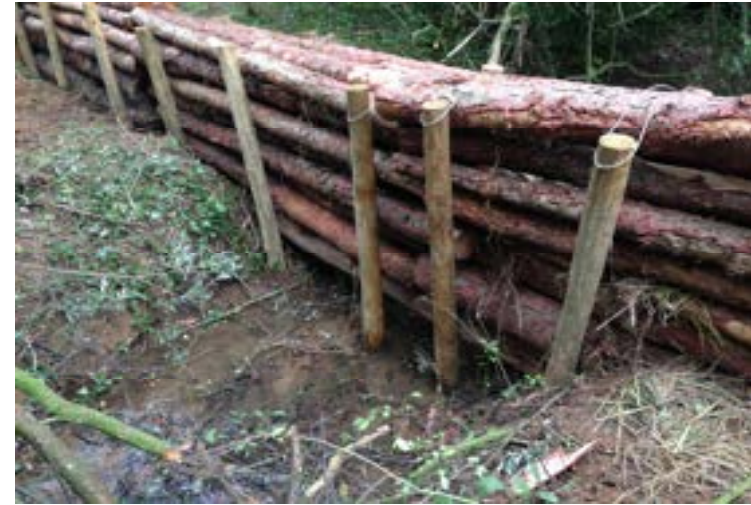
Old style leaky dam as built

- **Very little information on the longevity and fate of leaky barriers (impacts for cost effectiveness)**
- **Theoretically expected to last only 5-10 years (CIRIA 2022)**
- **WFF 30 original-style dams: put in place 2017-19**
- **Of these:**
 - **40% lost in first 7 years (27% in first 3 years)**
 - **20% have now partially collapsed**
 - **40% still in reasonable condition**
- **All significant collapses occurred in floods / storms (e.g. Babet and Henk)**
- **Most damage to barriers in larger streams (1.5 - 2 m wide)**

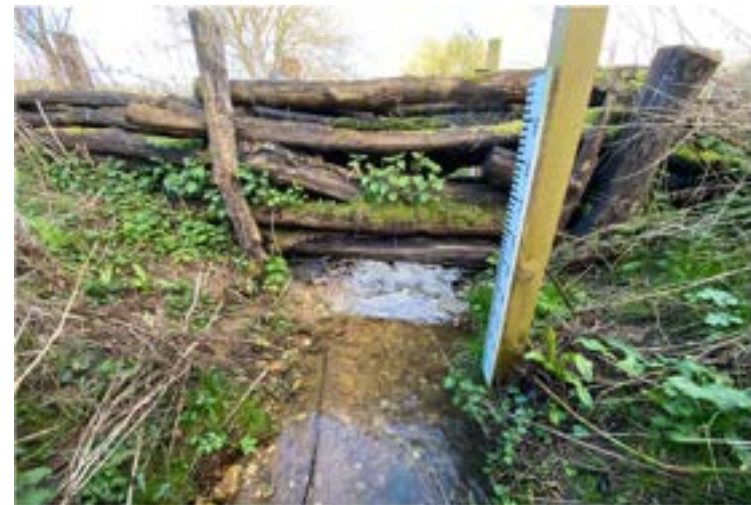
Old style leaky dam still functioning after seven years

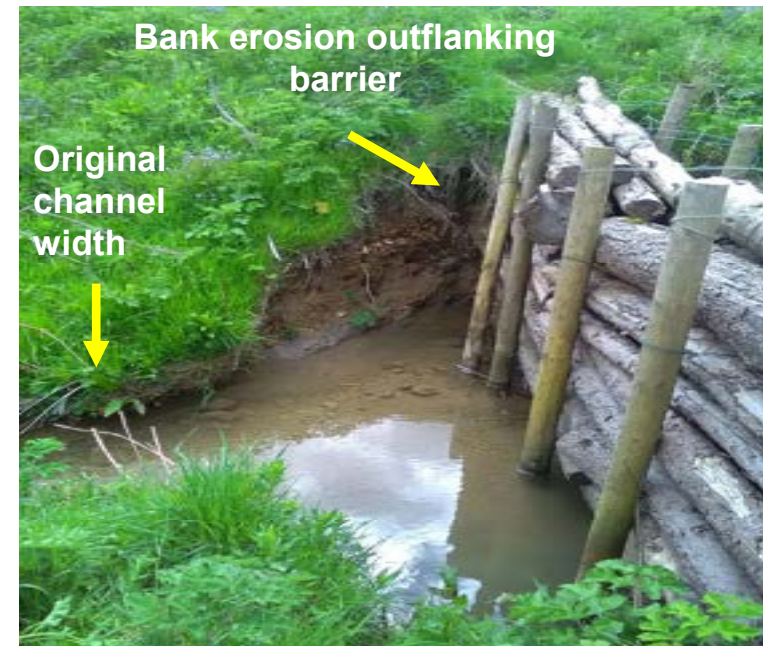
Dam which later failed catastrophically due to bank erosion

- All dams lost through bank erosion effects out-flanking the logs.
- Local bank erosion typically significant: double-triple the width of the channel
- So, replacement dams need to be located in new sites
- No dams lost through the logs rotting away: in some dams up to 25% of the logs are showing significant rotting creating holes (but these dams are just more 'leaky')

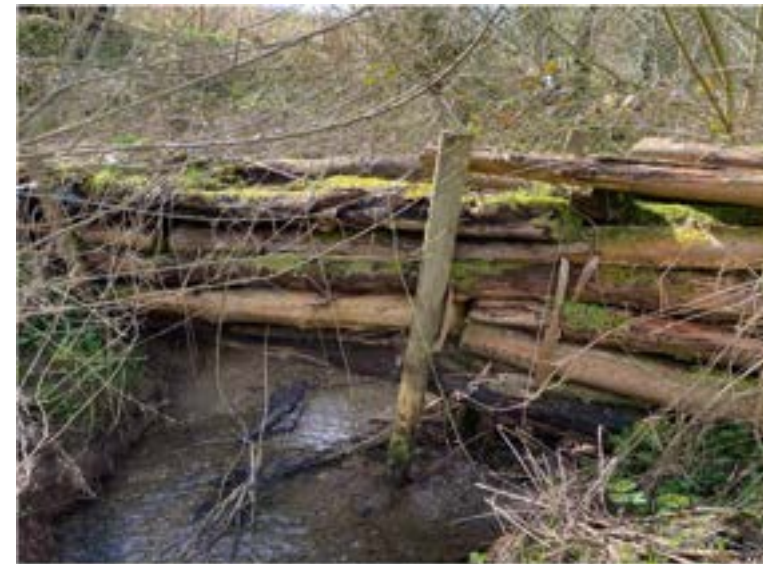
Seven year-old dam, still functioning but with some rotting timbers

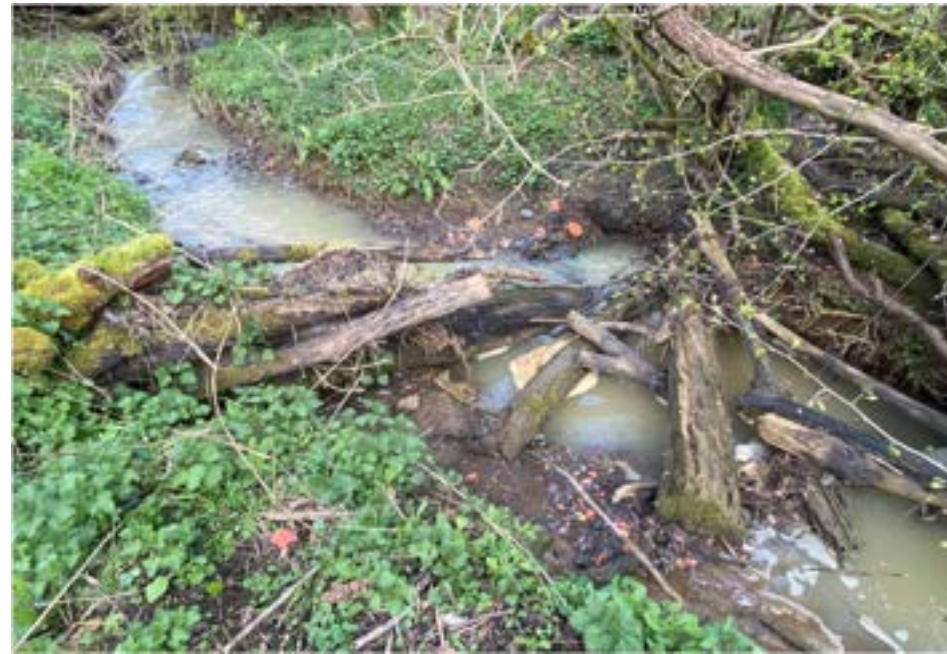
Dam gradually disintegrating and losing logs

- Two were catastrophic losses in flood (but both dams previously degraded)
- Five are gradually disintegrating and losing logs downstream
- Four are collapsing into debris dams and raising bed levels upstream by 20-30 cm

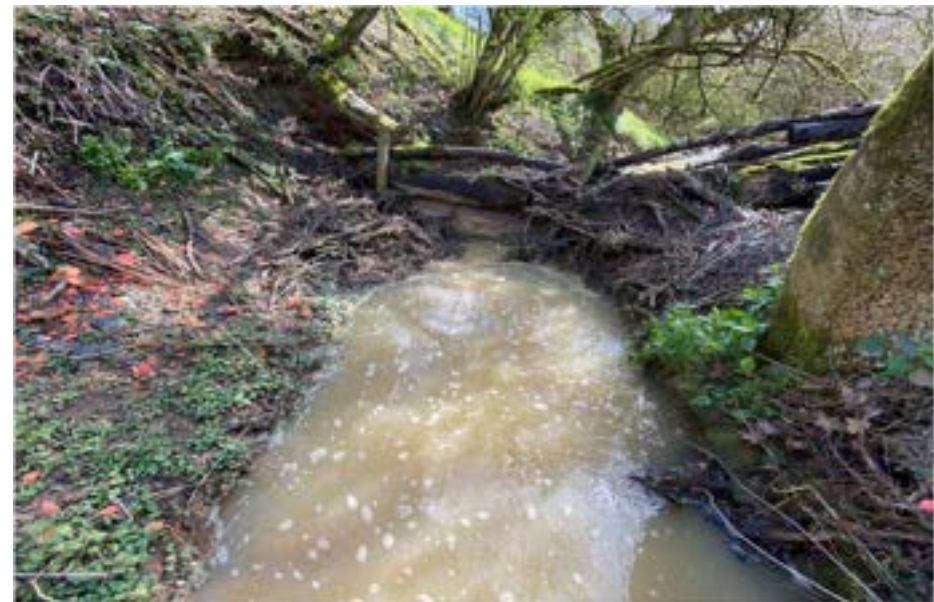
Dam silted up at the base: now acting like a debris dam

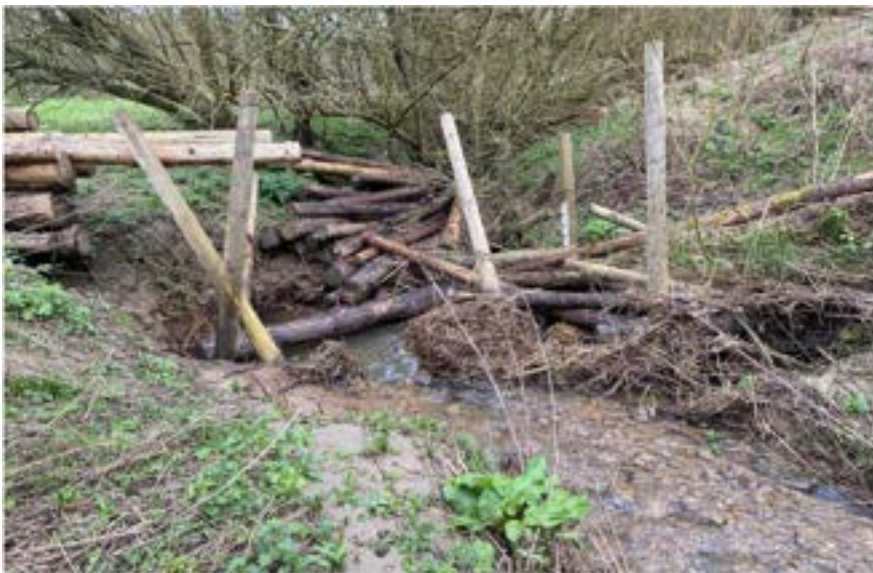
Dam collapsed catastrophically. All logs trapped trees and a narrow channel

- Often concern about the fate of logs from failed dams
- We generally removed logs from collapsing dams
- Some logs got away – generally caught by lower dams or trees. No evidence of other issues e.g. damage to bridge footings
- Are now leaving some dams to collapse naturally and track logs (number tags)

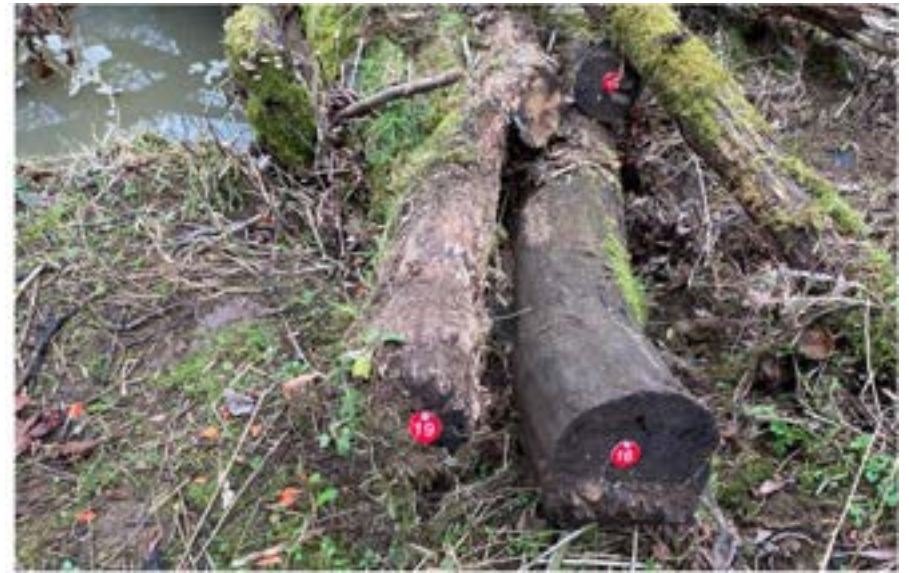
Number tags to track the logs of a degrading dam

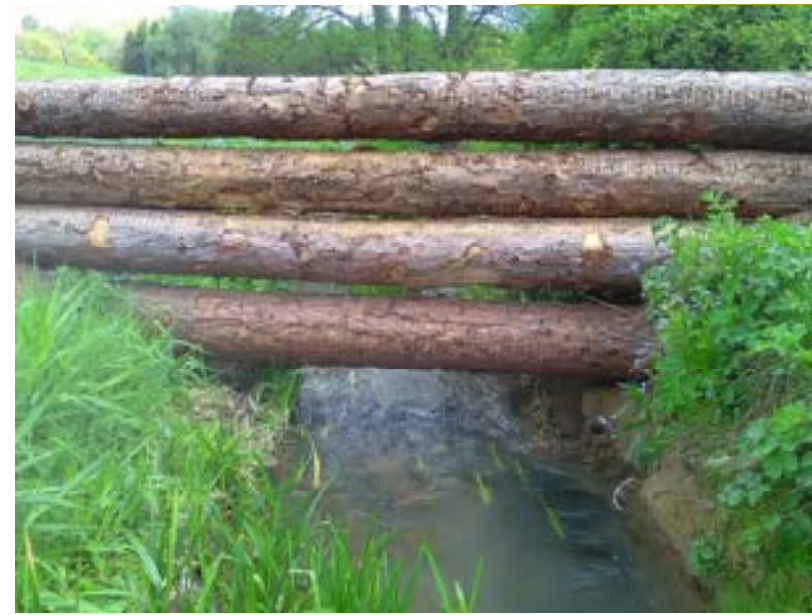
New style leaky dam on the Eye Brook

- Stronger: Single span logs
- Embedded: logs long enough to be embedded up to 2 m into the bank (stable even with bank erosion)
- Drain quickly: logs spaced apart so flood water does not remain trapped behind the barrier encouraging erosion
- Safer? Long logs so shouldn't move far downstream if dam collapses.

- 2020: 10 dams (8 replacements, 2 new)
- All still stable and in good condition after 4 years (including major floods)
- Much better design: more stable but...
- (i) more expensive and (ii) still significant bank erosion (up to double stream width), so may eventually collapse.

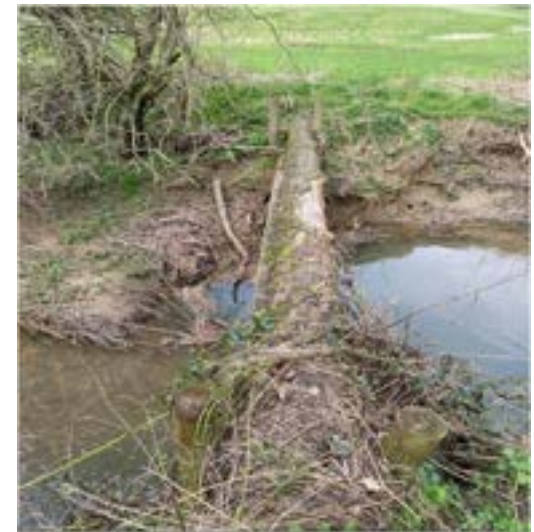
Significant bank erosion around a new style dam following 2023/24 flood events

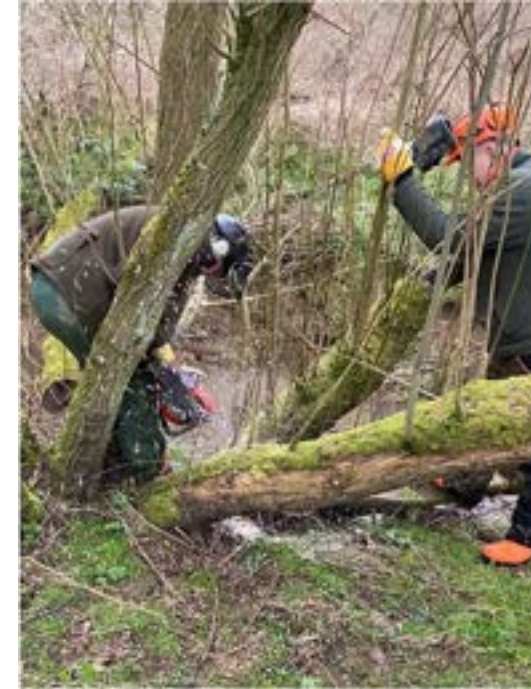
Tree hinging on the Eye Brook

- Trial use of different types of live wood barriers
- Hinging bankside willow (i) into the water (ii) over streams (iii) onto the bank to create barriers
- Also other species (hawthorn, blackthorn, hazel, alder)
- First trials 2022/23 – seemed to have worked well, significant ability to increase roughness and back-up water in flood.
- 2023/24 – extended to seven more sites using different techniques.

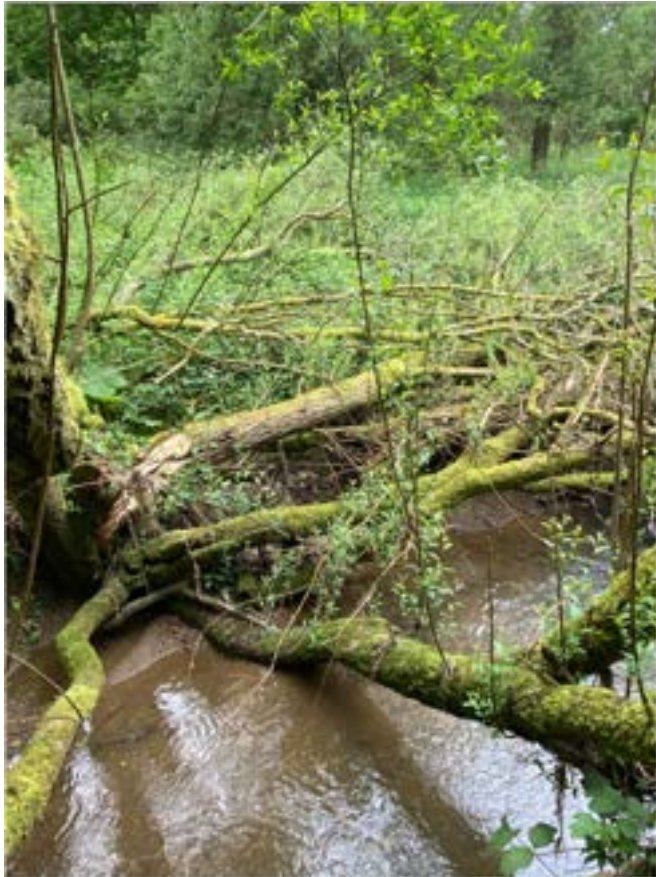
Willow hinged *into* stream

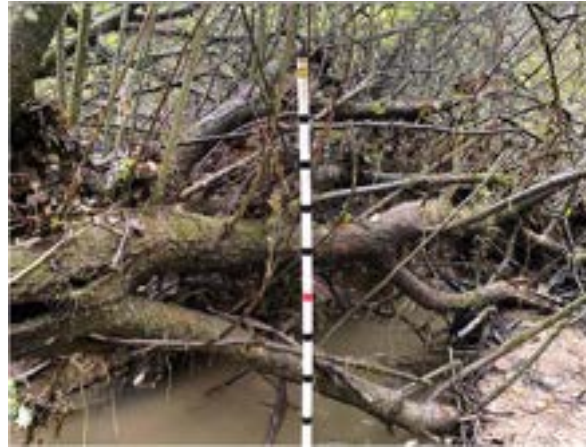
Hinged willow: stable and apparently effective after 2023/24 flooding that caused catastrophic loss of an adjacent traditional dam

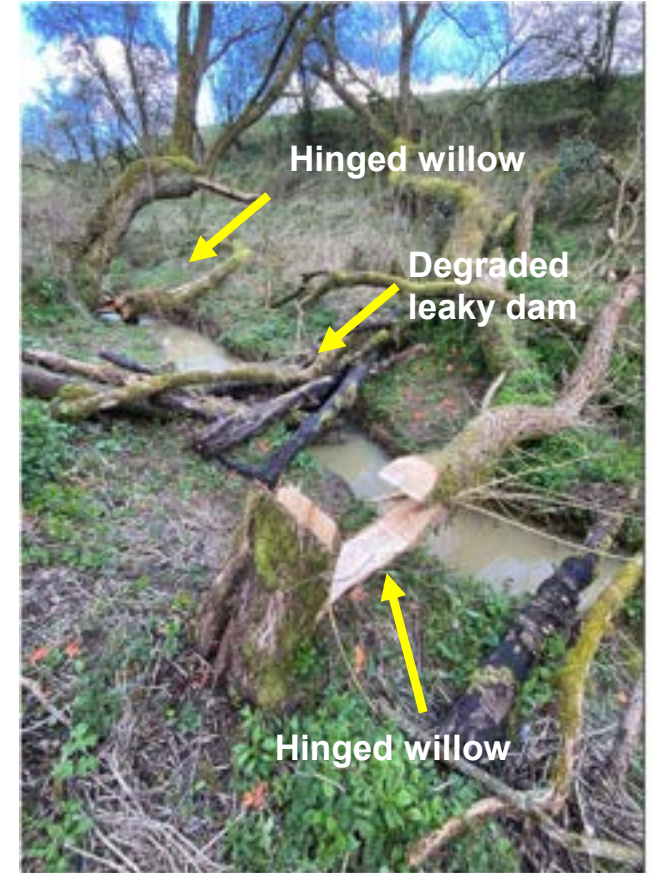
Willow hinged over stream. Degraded traditional dam in mid picture

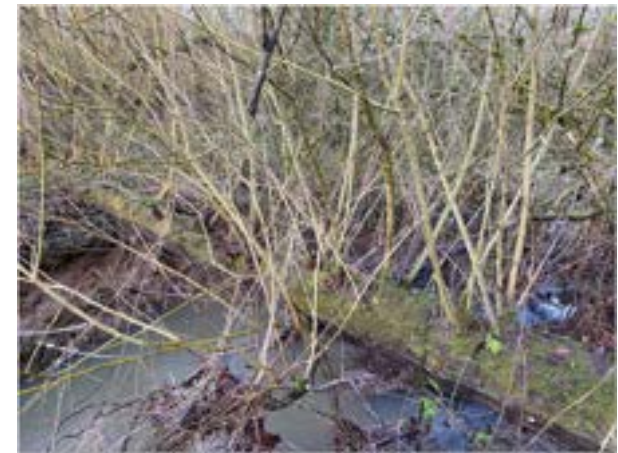
Vertical willow shoots on a hinged log prior to laying / weaving

Growth of willow also offers additional opportunities – e.g. laid or woven barriers to adjust the height or permeability

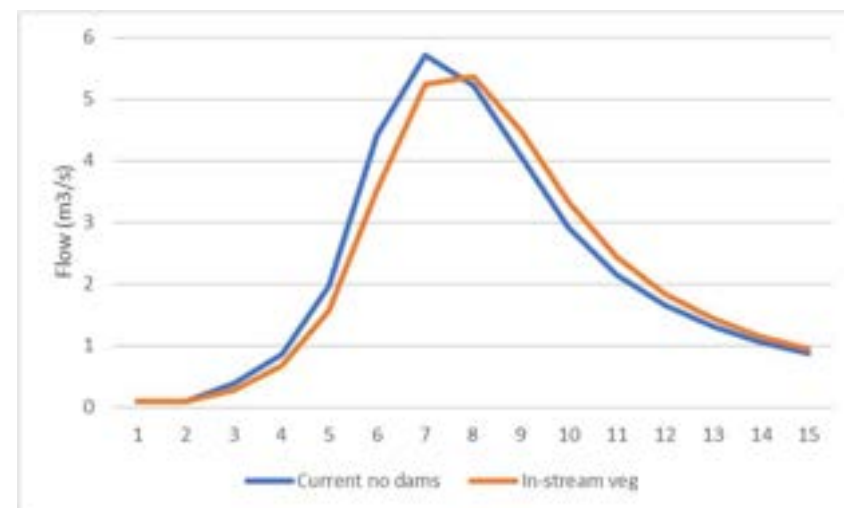
- Another potential way to slow flood flows is to increase the amount of vegetation in channel
- WFF streams are very heavily overshadowed by trees – with little channel vegetation.
- What would happen if we opened up sections to allow more aquatic plants to grow, and increase roughness?
- To look at this we modelled the effect
- **Result**: 6% reduction in flood peak

10% AEP ('1 in 10')

5.9% Peak flow reduction
1-hour peak flow delay

- Were planning experiments to look at this
- But observations from a tree-cleared area in Stonton catchment showed flood events in these small fast-flowing upper catchments uproot and wash channel plants away
- For UPPER catchments, not a viable option.

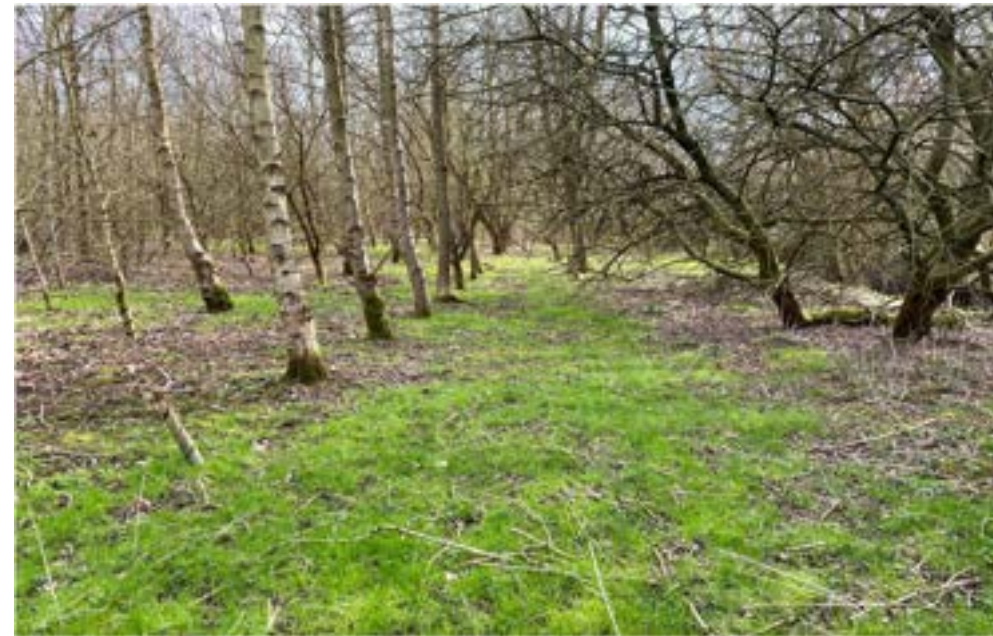
Typical woodland planting on Eye Brook floodplain (10+ years): very low roughness

- Been considering increasing overbank roughness to slow flood flows
- Standard option, as widely applied in the real world, is riparian planting
- Our observations (in WFF and other catchments): riparian planting typically has very low Manning's roughness.
- Have significant reservations about its effectiveness for roughing up floodplains – so have *not* progressed this
- Our view: need alternative forms of *floodplain* landcover e.g. low scrub/bramble (*pers. obs*) to be effective
- But appears to be no standard roughness indices for this land cover type, and no evidence that others are trialling in practice.
- So progressing this is very new...

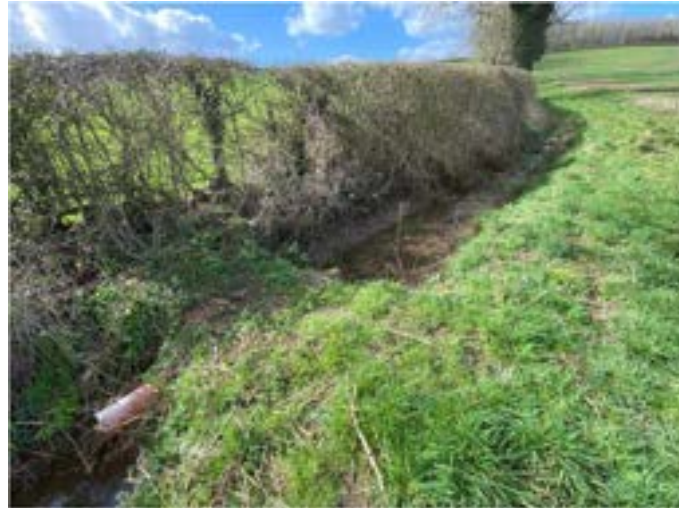
Small bund

- Earth bunds with channel excavation,
- Area: varied from 10m² to 150m²

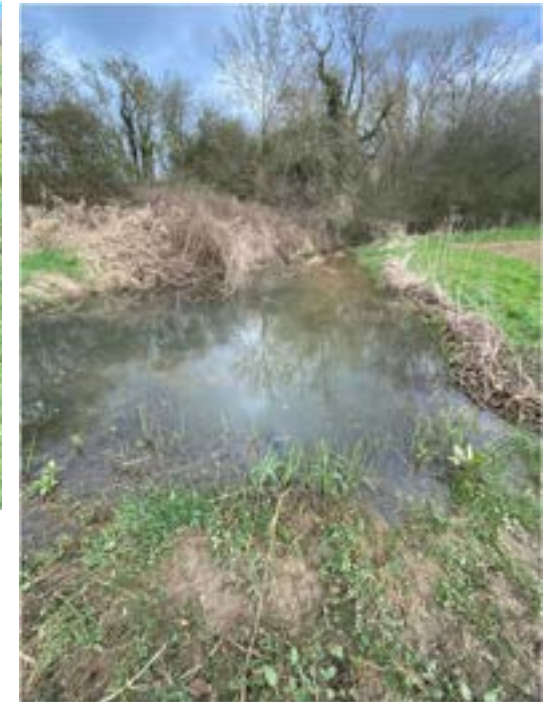
Large bund

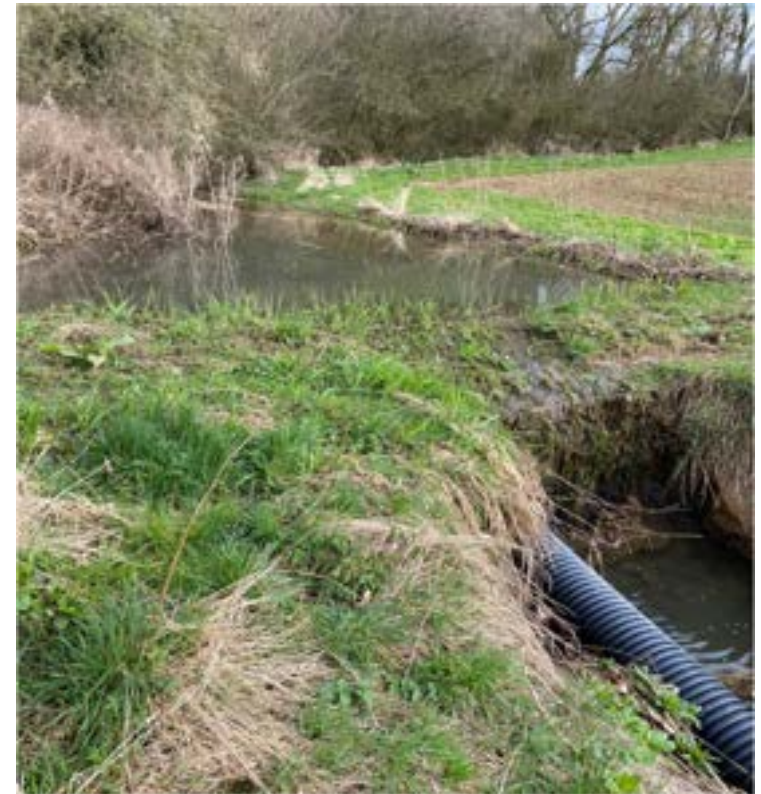
A bunded ditch full of sediment. Over-bund erosion has already eroded away 80% of the bund width and it is now close to (catastrophic?) collapse

- **Sediment fill:** most filled with sediment within 4-10 years (mainly during floods)
- **Significant rate of damage: 56% of dams had significant structural issues after 10 years:** either holes through the dam or erosion of the dam top.
- **Damage most likely when bunds are full of sediment:** blocked outlet pipes and bund erosion
- **Construction:** wide, well-compacted, dams may help reduce breaches through the dam
- **BUT essential to have a regular commitment to dredging-out** to prevent rapid degradation when dams are full (possible catastrophic loss)
- **This appears to be the first assessment. Our view:** a liability if not regularly dredged and maintained. Useful info for AES.

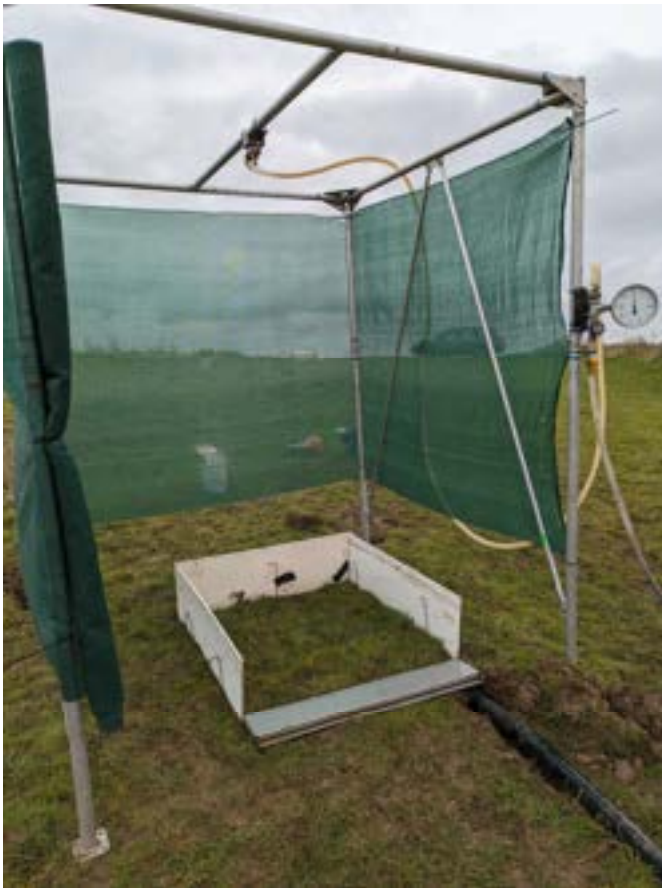
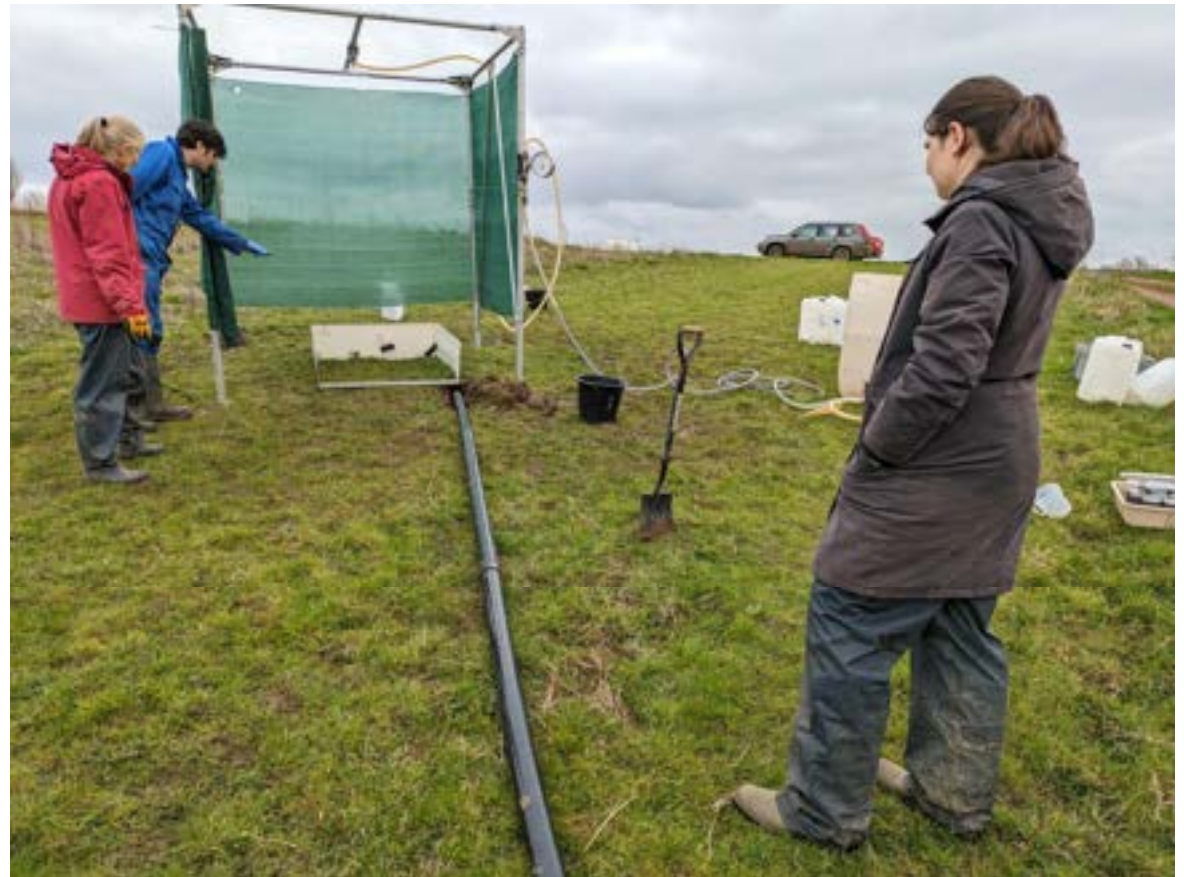
Purpose built rainfall simulator on loan from Cranfield University

- In Water Friendly Farming evaluating soil management by re-running our SWAT model of catchments with more realistic soil infiltration
- This is perhaps most difficult part of the project as practical measurement of infiltration is challenging
- **Main steps:**
 - Estimate carbon content of different soil types/agri-scheme soil management measures (e.g. no-till areas, flower-rich margins)
 - Measure ‘in the field’ infiltration rates in different soil types/agri-scheme measures
 - Measure in the lab soil moisture capacity of different soil types (with Cranfield Uni) – sand table at Cranfield University
 - Re-run whole catchment model with new ‘real-world’ infiltration and soil carbon data evaluating effect of soil management on runoff and flows

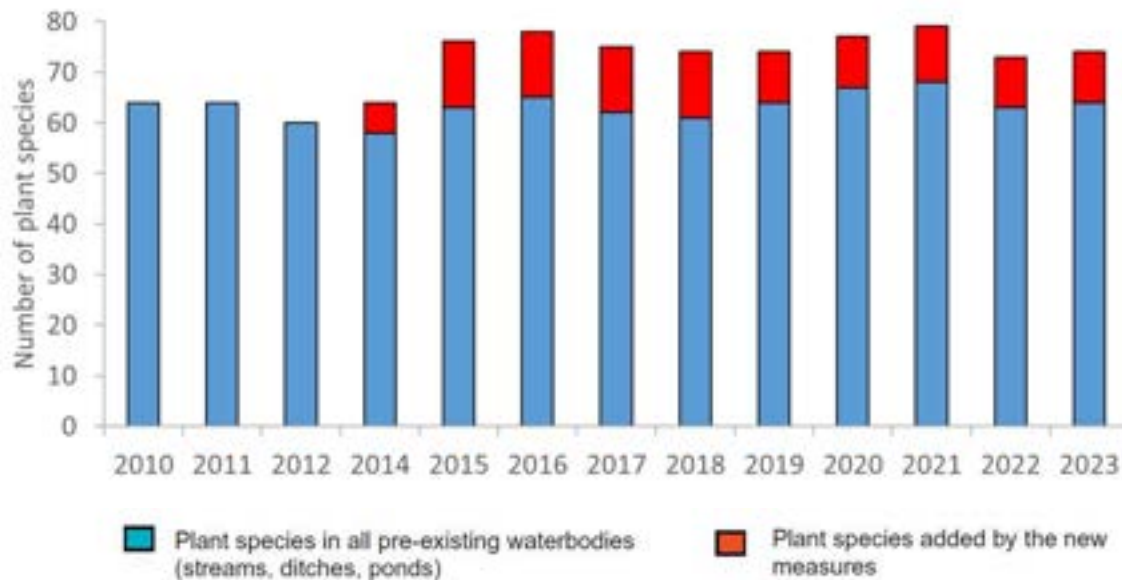
Stonton catchment: wetland plant species added by new ponds compared to all other habitats

- Creating clean ponds reversed the decline, delivering a 16% increase in biodiversity across the catchment; c80% increase in uncommon species 2023

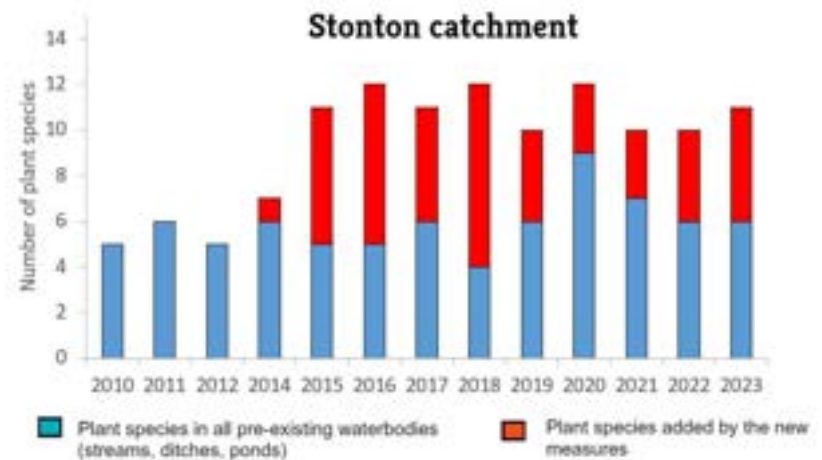
Uncommon wetland plant species found in new ponds compared to all other habitats

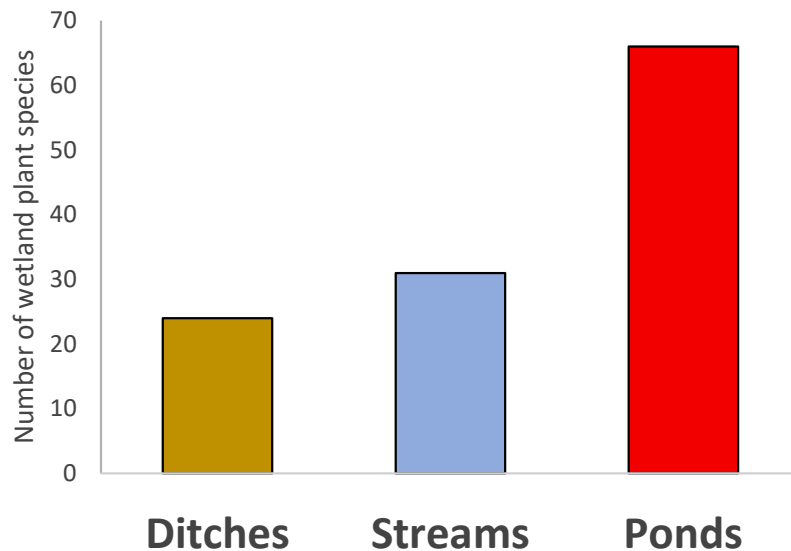
Number of plant species in different waterbody types

- Ponds crucial component of freshwater landscape
- Creating and managing ponds increased wetland plant species richness in the landscape by 19% and enabled many regionally uncommon species to return
